**Flood Control Project Maintenance
Levee Inspections****LMA District Cover Sheet
Spring 2015 Levee Inspection Results****Reclamation District No. 1500 Sutter Basin**

Spring 2015 Levee Inspection Results

Reclamation District No. 1500 Sutter Basin

Waterway			Bank	Unit Miles
Unit No. 01 Sacramento River			Left	33.15
	Spring (March - May)	Summer (June - August)	(September - November) Fall	Winter (December - February)
Unit Maintenance Rating (Fall Only)				
Date of Inspection	05/13/2015 - 05/14/2015			
DWR Inspector	Jai Lor			
Accompanied By

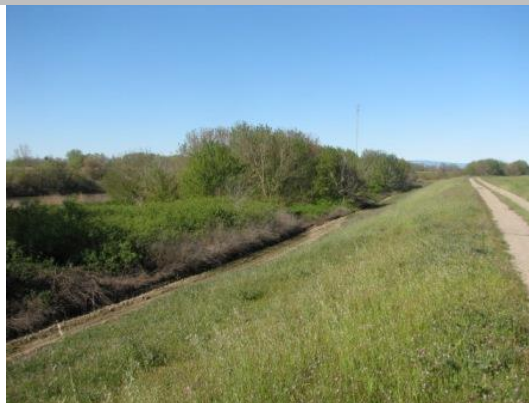
Photo 1 of 2 : SP_2015_RD1500_189_72_20150401_00050.jpg

LM Start	0.56	Rating **	A/W	Issue No.	72
LM End	0.82	Issue Type +	Ma	Location *	WS
Category	Earthen Levee			GPS Latitude/Longitude	
				Start	End
Item	Vegetation			38.764462 °	38.764638 °
				-121.683167 °	-121.687690 °
DWR ID	DWR_RD1500_01_s _ 2012_72				
Action/Comments					
Environmental Requirements.

A view of the revegetation site.

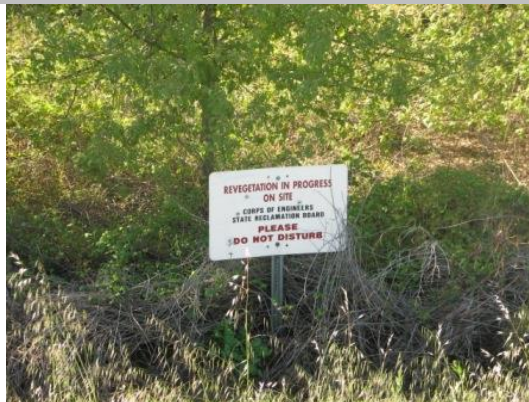
Photo 2 of 2 : SP_2015_RD1500_189_72_20150401_00051.jpg

LM Start	0.56	Rating **	A/W	Issue No.	72 (cont)
LM End	0.82	Issue Type +	Ma	Location *	WS

A revegetation site waterside toe, photo taken spring 2012.

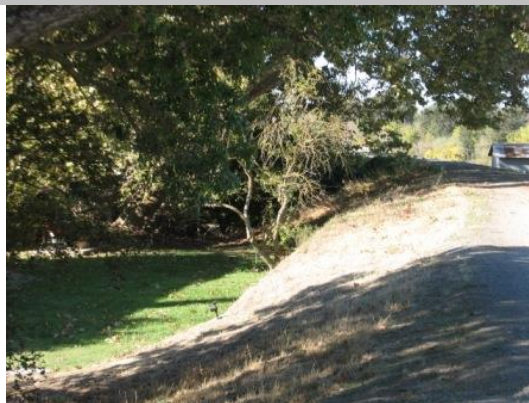
Photo 1 of 1 : SP_2015_RD1500_189_4_20150401_00004.jpg

LM Start	1.32	Rating **	M	Issue No.	4
LM End	1.32	Issue Type +	En	Location *	N/A
Category	Earthen Levee			GPS Latitude/Longitude	
				Start	End
Item	Vegetation			38.770003 °	38.770003 °
				-121.690607 °	-121.690607 °
DWR ID	DWR_RD1500_01_s_2012_4				
Action/Comments					
Landscaping					
Inspector Comments: Retaining wall built into the levee.

Landscape with retaining wall that is in the USACE as-builts Fall 2013

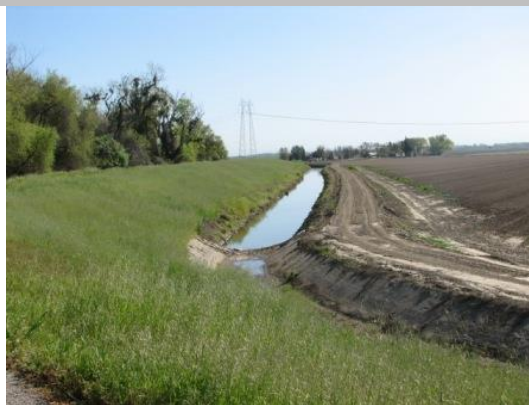
Photo 1 of 1 : SP_2015_RD1500_189_963_20150401_00070.jpg

Action/Comments					
Ditch

Agricultural ditch, photo was taken in spring 2010.

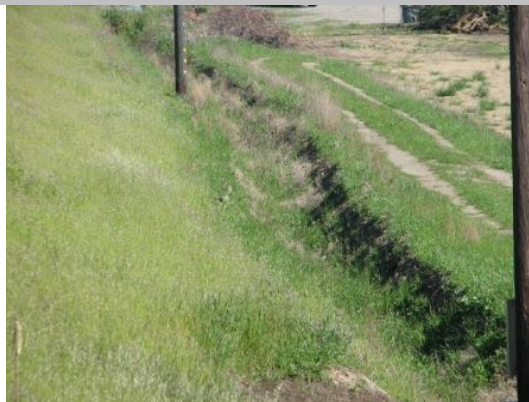
Photo 1 of 1 : SP_2015_RD1500_189_54_20150401_00045.jpg

LM Start	4.02	Rating **	M	Issue No.	54
LM End	4.12	Issue Type +	En	Location *	LS
Category	Earthen Levee			GPS Latitude/Longitude	
				Start	End
Item	Encroachments			38.798572 °	38.800080 °
				-121.696392 °	-121.696653 °
DWR ID	DWR_RD1500_01_s_2012_54				
Action/Comments					
Ditch

An agricultural ditch runs along the toe of the levee, photo taken spring 2012.

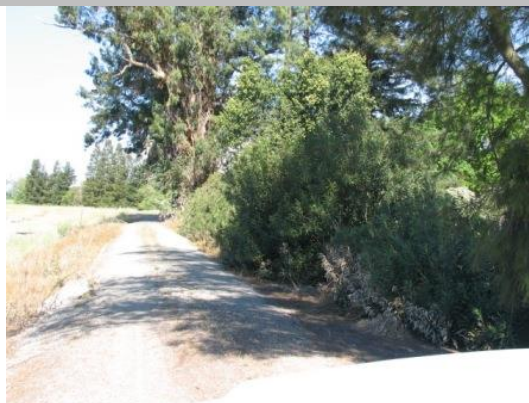
Photo 1 of 1 : SP_2015_RD1500_189_14_20150401_00011.jpg

LM Start	5.34	Rating **	M	Issue No.	14
LM End	5.34	Issue Type +	En	Location *	LS
Category	Earthen Levee			GPS Latitude/Longitude	
				Start	End
Item	Vegetation			38.803240 °	38.803240 °
				-121.715402 °	-121.715402 °
DWR ID	DWR_RD1500_01_s _ 2012_14				
Action/Comments					
Landscaping

The landscape completely blocks the landside slope and toe.

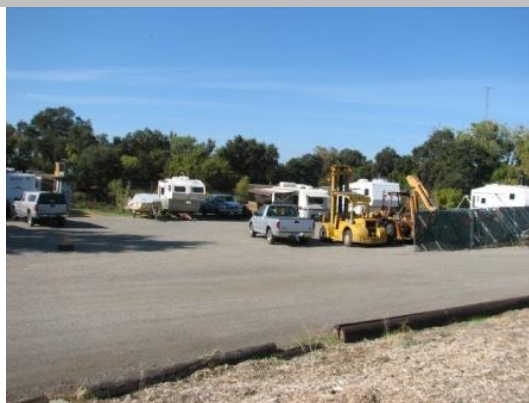
Photo 1 of 2 : SP_2015_RD1500_189_52_20150401_00042.jpg

LM Start	5.61	Rating **	M	Issue No.	52
LM End	5.69	Issue Type +	En	Location *	WS
Category	Earthen Levee			GPS Latitude/Longitude	
				Start	End
Item	Encroachments			38.803005 °	38.803238 °
				-121.720380 °	-121.721847 °
DWR ID	DWR_RD1500_01_s _ 2012_52				
Action/Comments					
Building					
Inspector Comments: Sting Rayz Beach Boardwalk Marina on the waterside berm.

String Rayz RV park, Fall 2013

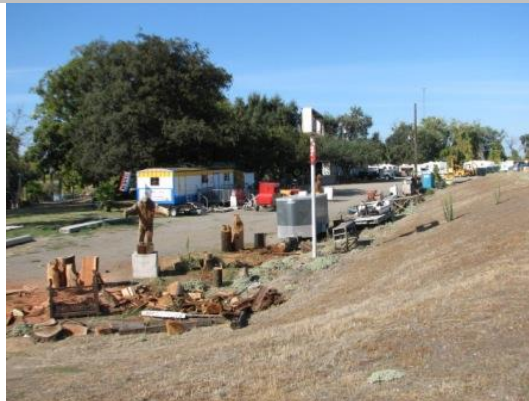
Photo 2 of 2 : SP_2015_RD1500_189_52_20150401_00043.jpg

LM Start	5.61	Rating **	M	Issue No.	52 (cont)	
LM End	5.69	Issue Type +	En	Location *	WS	
Category	Earthen Levee			GPS Latitude/Longitude		
				Start		End
Item	Encroachments			38.803005 °		38.803238 °
				-121.720380 °		-121.721847 °
DWR ID	DWR_RD1500_01_s _ 2012_52					
Action/Comments						
Building						
Inspector Comments: Sting Rayz Beach Boardwalk Marina on the waterside berm.

String Rayzs, Fall 2013

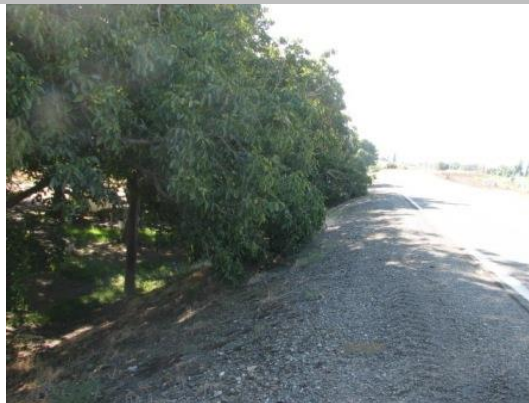
Photo 1 of 1 : SP_2015_RD1500_189_217_20150401_00067.jpg

Trees need to be trimmed to the height of 5 feet to see the slope.

LM Start	7.15	Rating **	M	Issue No.	217
LM End	7.15	Issue Type +	Ma	Location *	LS
Category	Earthen Levee			GPS Latitude/Longitude	
				Start	End
Item	Trim / Thin Trees			38.824119 °	38.824119 °
				-121.722776 °	-121.722776 °
DWR ID	DWR_RD1500_01_s _ 2012_217				
Action/Comments					
Trim trees to at least five feet above ground level.

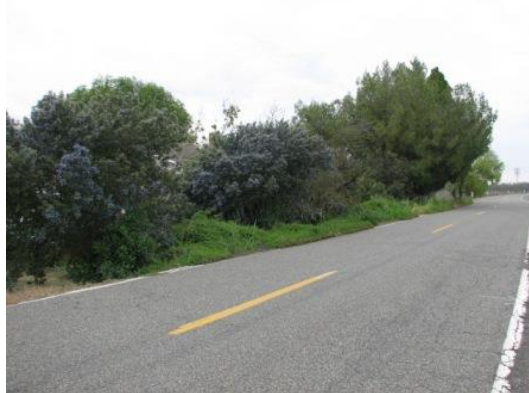
Photo 1 of 2 : SP_2015_RD1500_189_17_20150401_00014.jpg

LM Start	7.60	Rating **	M	Issue No.	17
LM End	7.60	Issue Type +	En	Location *	LS
Category	Earthen Levee			GPS Latitude/Longitude	
				Start	End
Item	Vegetation			38.830260 °	38.830260 °
				-121.725357 °	-121.725357 °
DWR ID	DWR_RD1500_01_s_2012_17				
Action/Comments					
Landscaping

Landscape shrubs, photo taken in spring 2010.

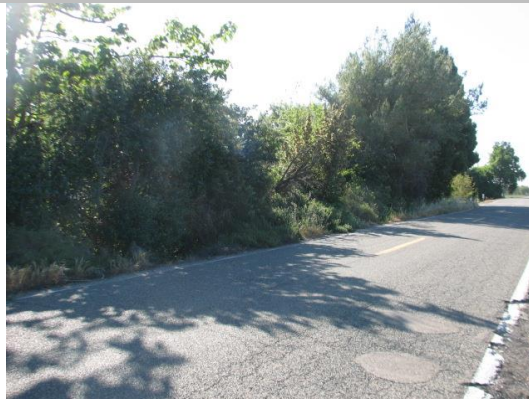
Photo 2 of 2 : SP_2015_RD1500_189_17_20150401_00015.jpg

A current view of the landscape on the levee slope. Spring 2014

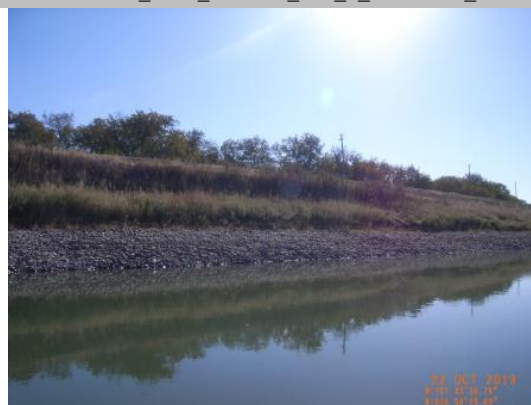
Photo 1 of 1 : SP_2015_RD1500_189_3_20150401_00003.jpg

Action/Comments					
Inspector Comments: 1997 - Damage to cobble revetment on top left bank and toe damage. 2004 - Site is pretty minor. 2010 - Cobbles continue to deteriorate. 2011 - Minor new erosion at the toe. 2013: Might be able to shorten due to deposition. [2013 Site ID: SAC_92-8_L]

USACE 2013 Photo #1

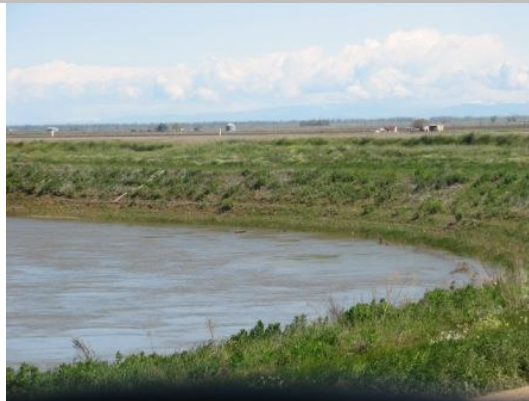
Photo 1 of 2 : SP_2015_RD1500_189_74_20150401_00052.jpg

LM Start	9.40	Rating **	A/W	Issue No.	74
LM End	9.63	Issue Type +	Ma	Location *	WS
Category	Earthen Levee			GPS Latitude/Longitude	
				Start	End
Item	Vegetation			38.850267 °	38.853222 °
				-121.723275 °	-121.724062 °
DWR ID	DWR_RD1500_01_s_2012_74				
Action/Comments					
Environmental Requirements.

A revegetation site on the waterside bank with sprinklers installed.

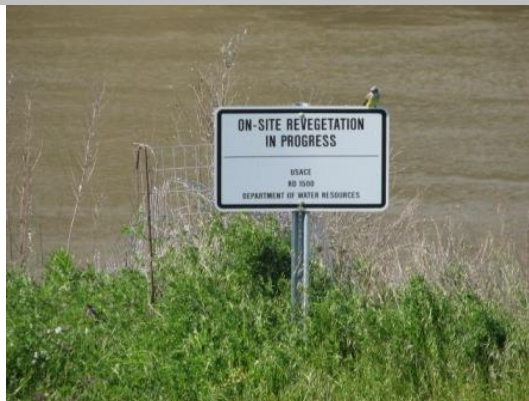
Photo 2 of 2 : SP_2015_RD1500_189_74_20150401_00053.jpg

Another revegetation site photo taken spring 2012.

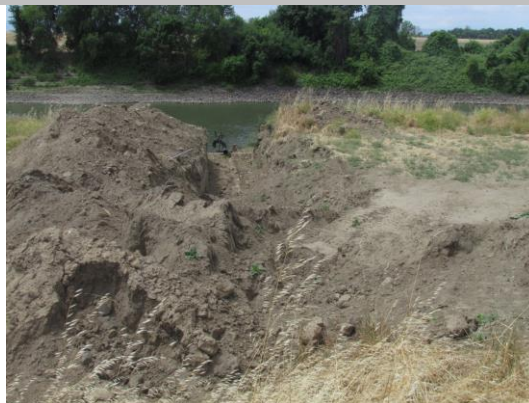
Photo 2 of 2 : SP_2015_RD1500_189_2548_20150514_03096.jpg

LM Start	11.23	Rating **	U	Issue No.	2548 (cont)	
LM End	11.23	Issue Type +	En	Location *	WS	
Category	Earthen Levee			GPS Latitude/Longitude		
				Start		End
Item	Encroachments			38.865649 °		38.865649 °
				-121.745255 °		-121.745255 °
DWR ID	DWR_RD1500_01_s _ 2015_2548					
Action/Comments						
Pipe						
Inspector Comments: Owner is applying for a permit for an existing pipe. This issue was given an NOV on April 15, 2015.

View of the dug out trench for the pipe on the waterward side of the levee. Spring 2015.

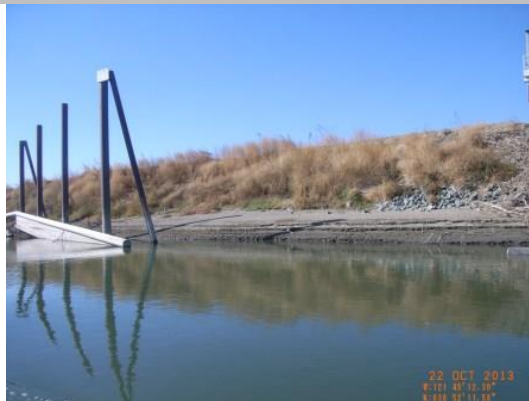
Photo 1 of 1 : SP_2015_RD1500_189_10_20150401_00008.jpg

LM Start	12.14	Rating **	M	Issue No.	10
LM End	12.14	Issue Type +	Ma	Location *	WS
Category	Supplemental			GPS Latitude/Longitude	
				Start	End
Item	USACE Erosion Survey			38.870474 °	38.869139 °
				-121.752237 °	-121.757108 °
DWR ID	DWR_RD1500_01_f_2014_10				
Action/Comments					
Inspector Comments: 2000 - Vertical Modesto Formation bank with mass failure. 2003 - Upstream end has some new bank retreat. 2004 - Upstream end is worse. 2006 - Some new erosion, mainly on the steep slope and scarps. (Pumping station is not part of the erosion site.) 2010 - Some new erosion and deposition at upstream end, definite encroachments. 2011 - Minor new erosion at the toe. 2013: No observed changes. [2013 Site ID: SAC_96-2_L]

USACE 2013 Photo #1

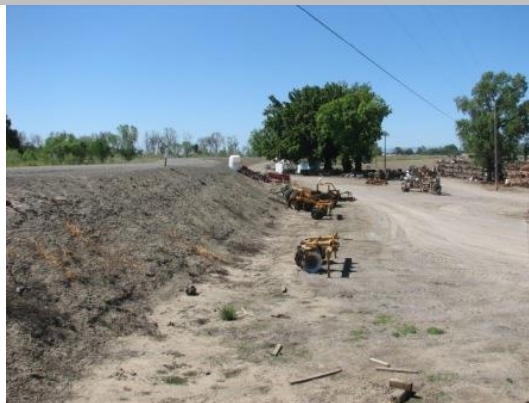
Photo 1 of 2 : SP_2015_RD1500_189_24_20150401_00021.jpg

LM Start	12.43	Rating **	M	Issue No.	24
LM End	12.43	Issue Type +	Ma	Location *	LS
Category	Earthen Levee			GPS Latitude/Longitude	
				Start	End
Item	Encroachments			38.868717 °	38.868717 °
				-121.760133 °	-121.760133 °
DWR ID	DWR_RD1500_01_s_2012_24				
Action/Comments					
Equipment

There is equipment parked along the toe of the levee.

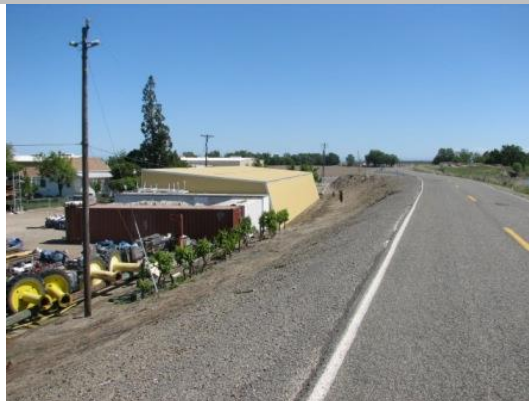
Photo 1 of 1 : SP_2015_RD1500_189_26_20150401_00024.jpg

LM Start	13.01	Rating **	M	Issue No.	26
LM End	13.01	Issue Type +	En	Location *	LS
Category	Earthen Levee			GPS Latitude/Longitude	
				Start	End
Item	Encroachments			38.863438 °	38.863438 °
				-121.768212 °	-121.768212 °
DWR ID	DWR_RD1500_01_s _ 2012_26				
Action/Comments					
Building

The building's backside was built into the toe of the levee.

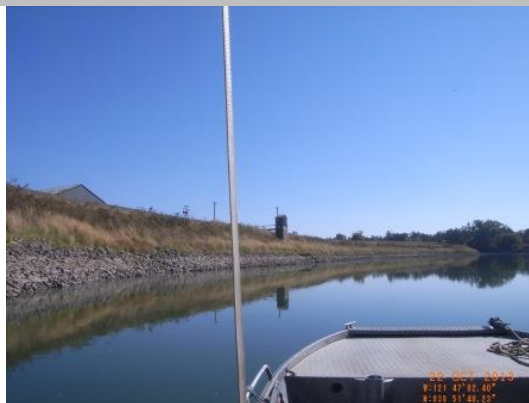
Photo 1 of 1 : SP_2015_RD1500_189_15_20150401_00012.jpg

LM Start	13.98	Rating **	M	Issue No.	15
LM End	14.28	Issue Type +	Ma	Location *	WS
Category	Supplemental			GPS Latitude/Longitude	
				Start	End
Item	USACE Erosion Survey			38.857239 °	38.861899 °
				-121.783771 °	-121.784057 °
DWR ID	DWR_RD1500_01_f _ 2014_15				
Action/Comments					
Inspector Comments: 1997 - Intermittent toe failure of the hand placed riprap; failure of toe materials. 2013: No observed changes. [2013 Site ID: SAC_99-0_L]

USACE 2013 Photo #1

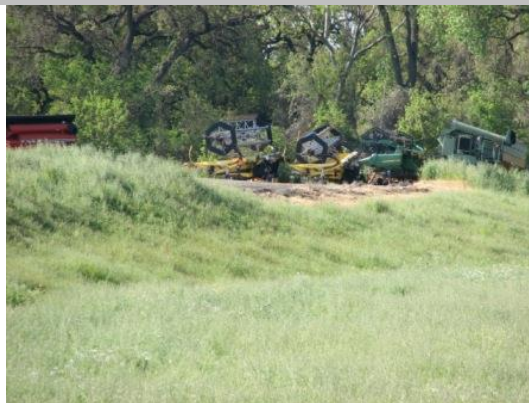
Photo 1 of 1 : SP_2015_RD1500_189_28_20150401_00025.jpg

LM Start	13.99	Rating **	A/W	Issue No.	28
LM End	13.99	Issue Type +	Ma	Location *	WS
Category	Earthen Levee			GPS Latitude/Longitude	
				Start	End
Item	Encroachments			38.857792 °	38.857792 °
				-121.783265 °	-121.783265 °
DWR ID	DWR_RD1500_01_s _ 2012_28				
Action/Comments					
Equipment

View of equipment. Photo was taken in spring 2010.

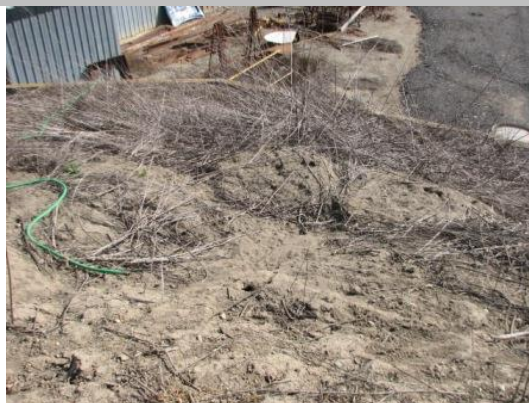
Photo 1 of 1 : SP_2015_RD1500_189_89_20150401_00063.jpg

Rodent hole in the levee slope above the retaining wall, Spring 2013

LM Start	14.18	Rating **	M	Issue No.	89
LM End	14.18	Issue Type +	Ma	Location *	LS
Category	Earthen Levee			GPS Latitude/Longitude	
				Start	End
Item	Animal Control			38.860452 °	38.860452 °
				-121.783294 °	-121.783294 °
DWR ID	DWR_RD1500_01_s _ 2013_89				
Action/Comments					
Exterminate rodents and backfill and compact or grout burrows.

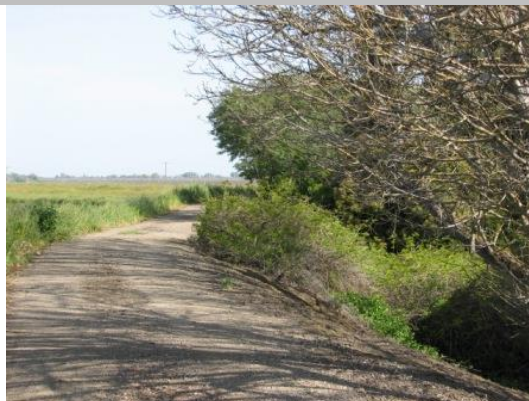
Photo 1 of 1 : SP_2015_RD1500_189_31_20150401_00028.jpg

LM Start	14.25	Rating **	M	Issue No.	31
LM End	14.25	Issue Type +	En	Location *	LS
Category	Earthen Levee			GPS Latitude/Longitude	
				Start	End
Item	Vegetation			38.861513 °	38.861513 °
				-121.783588 °	-121.783588 °
DWR ID	DWR_RD1500_01_s_2012_31				
Action/Comments					
Landscaping

Landscape shrubs on shoulder. Photo was taken in spring 2010.

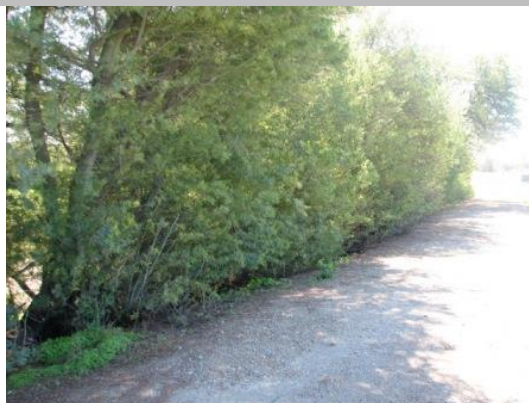
Photo 1 of 2 : SP_2015_RD1500_189_77_20150401_00056.jpg

LM Start	14.27	Rating **	U	Issue No.	77
LM End	14.27	Issue Type +	Ma	Location *	LS
Category	Earthen Levee			GPS Latitude/Longitude	
				Start	End
Item	Trim / Thin Trees			38.861793 °	38.861793 °
				-121.783703 °	-121.783703 °
DWR ID	DWR_RD1500_01_s_2012_77				
Action/Comments					
Trim and thin trees to allow visibility of the ground and room to flood fight.

The trees on the landside slope blocks the view of the slope, photo taken spring 2012.

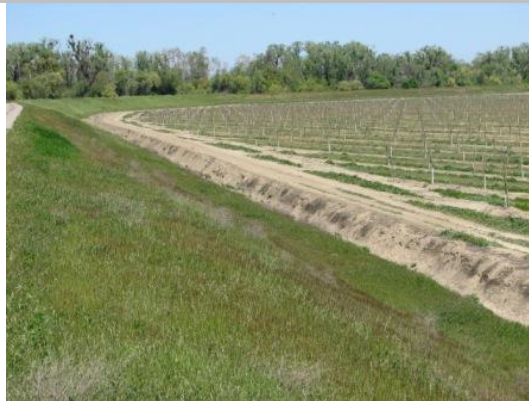
Photo 1 of 1 : SP_2015_RD1500_189_969_20150401_00071.jpg

LM Start	14.71	Rating **	M	Issue No.	969
LM End	15.76	Issue Type +	En	Location *	LS
Category	Earthen Levee			GPS Latitude/Longitude	
				Start	End
Item	Encroachments			38.865473 °	38.871752 °
				-121.789413 °	-121.804257 °
DWR ID	DWR_RD1500_01_s _ 2012_969				
Action/Comments					
Ditch

Agricultural ditch, photo taken in spring 2010.

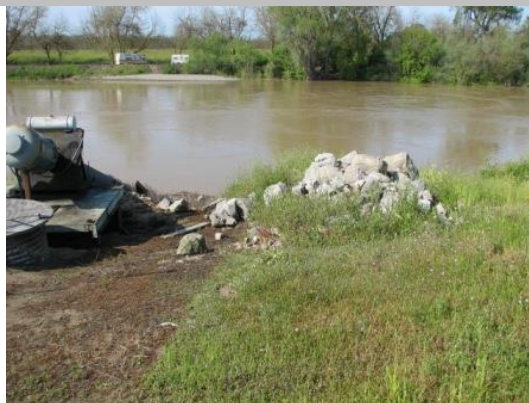
Photo 1 of 1 : SP_2015_RD1500_189_21_20150401_00018.jpg

LM Start	15.11	Rating **	M	Issue No.	21
LM End	15.11	Issue Type +	En	Location *	WS
Category	Earthen Levee			GPS Latitude/Longitude	
				Start	End
Item	Encroachments			38.866827 °	38.866827 °
				-121.794020 °	-121.794020 °
DWR ID	DWR_RD1500_01_s _ 2012_21				
Action/Comments					
Debris Inspector Comments: A pile of rip rap and concrete needs to be removed.

Rip rap and concrete debris, photo taken in spring 2010.

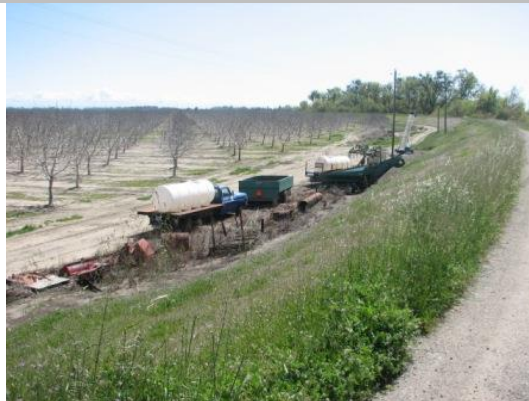
Photo 1 of 2 : SP_2015_RD1500_189_78_20150401_00058.jpg

LM Start	16.20	Rating **	M	Issue No.	78
LM End	16.20	Issue Type +	En	Location *	LS
Category	Earthen Levee			GPS Latitude/Longitude	
				Start	End
Item	Encroachments			38.874623 °	38.874623 °
				-121.811272 °	-121.811272 °
DWR ID	DWR_RD1500_01_s _ 2012_78				
Action/Comments					
Equipment

The equipment is parked along the toe of the levee, photo taken spring 2012.

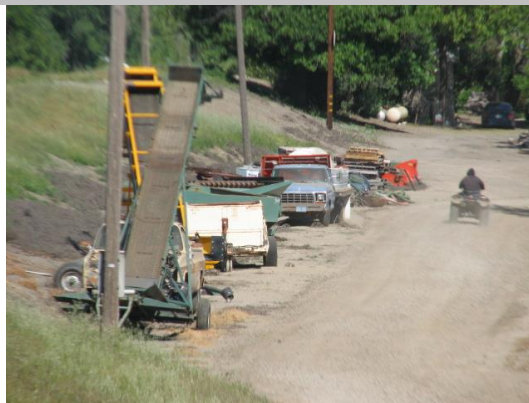
Photo 2 of 2 : SP_2015_RD1500_189_78_20150401_00059.jpg

A current view of equipment at the toe of the levee. Spring 2014

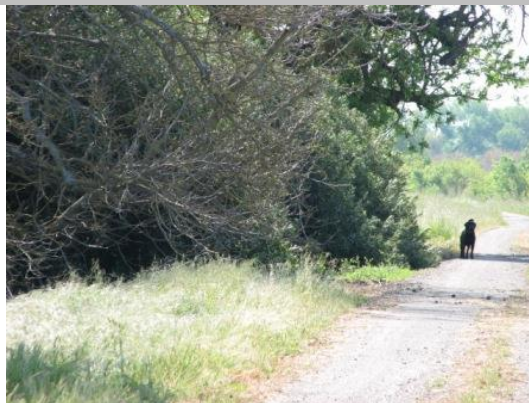
Photo 1 of 1 : SP_2015_RD1500_189_33_20150401_00030.jpg

LM Start	16.30	Rating **	U	Issue No.	33
LM End	16.30	Issue Type +	En	Location *	LS
Category	Earthen Levee			GPS Latitude/Longitude	
				Start	End
Item	Vegetation			38.875873 °	38.875873 °
				-121.812410 °	-121.812410 °
DWR ID	DWR_RD1500_01_s _ 2012_33				
Action/Comments					
Landscaping					
Inspector Comments: There is landscaping, including oleanders and other shrubs at this location.

Landscape shrubs, photo taken in spring 2010.

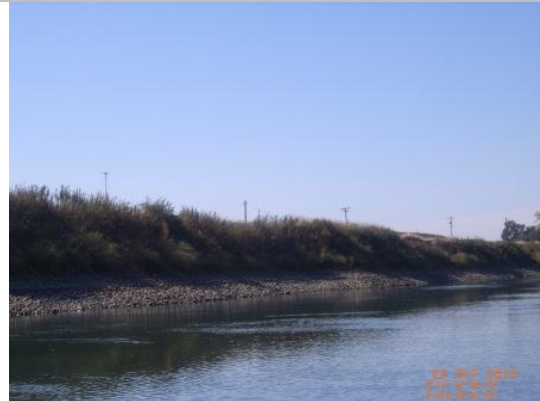
Photo 1 of 1 : SP_2015_RD1500_189_22_20150401_00019.jpg

LM Start	18.38	Rating **	M	Issue No.	22
LM End	19.06	Issue Type +	Ma	Location *	WS
Category	Supplemental			GPS Latitude/Longitude	
				Start	End
Item	USACE Erosion Survey			38.901337 °	38.902721 °
				-121.801175 °	-121.790677 °
DWR ID	DWR_RD1500_01_f_2014_22				
Action/Comments					
Inspector Comments: 1997 - Pocket failures of cobble revetment toe; scallops of rock loss along the bank; irregular bankline developing. 2001 - Small scallops in the toe of the berm. 2005 - Still multiple erosion pockets in the toe. 2006 - Two new small slumps. 2011 - Old cobble continue to fail causing minor slumping. 2012 - Portions of site appears to be stabilizing. 2013: No observed changes. [2013 Site ID: SAC_104-0_L]

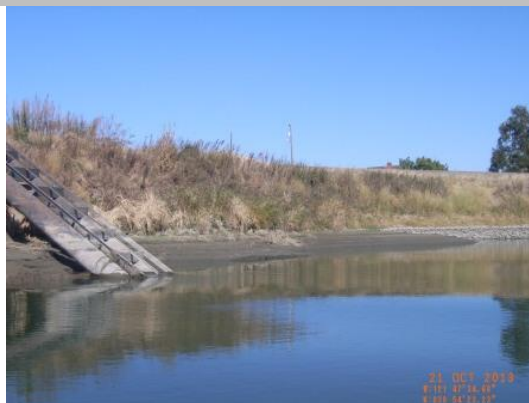
Photo 1 of 1 : SP_2015_RD1500_189_23_20150401_00020.jpg

LM Start	19.16	Rating **	M	Issue No.	23
LM End	19.47	Issue Type +	Ma	Location *	WS
Category	Supplemental			GPS Latitude/Longitude	
				Start	End
Item	USACE Erosion Survey			38.904041 °	38.906697 °
				-121.790298 °	-121.792796 °
DWR ID	DWR_RD1500_01_s _ 2015_23				
Action/Comments					
Inspector Comments: 1997 - Cobbles eroded off the clay materials; not much evidence of erosion on the toe; cobble loss on the toe. 2011 - Some minor new erosion. 2013: No observed changes. [2013 Site ID: SAC_104-5_L]

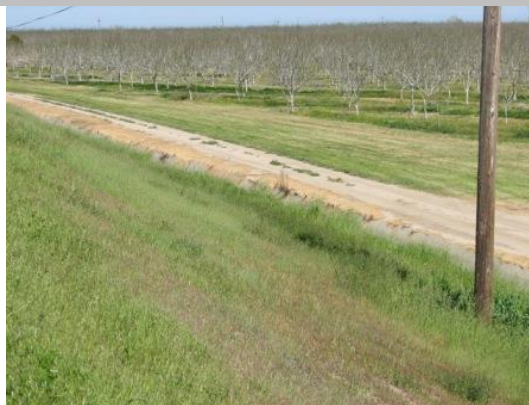
Photo 1 of 1 : SP_2015_RD1500_189_975_20150401_00074.jpg

Action/Comments					
Ditch

Agricultural ditch, photo taken in spring 2010.

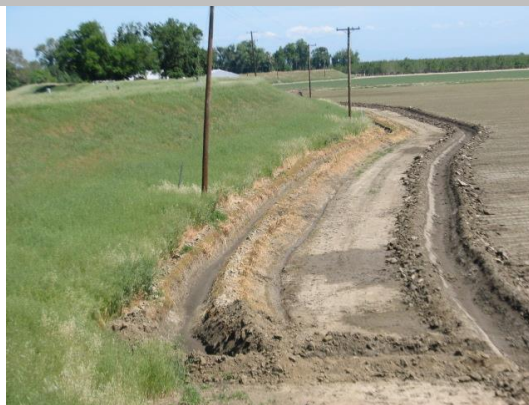
Photo 1 of 1 : SP_2015_RD1500_189_1349_20150401_00091.jpg

Action/Comments					
Ditch

Agricultural ditch runs along the toe of the levee. Spring 2014

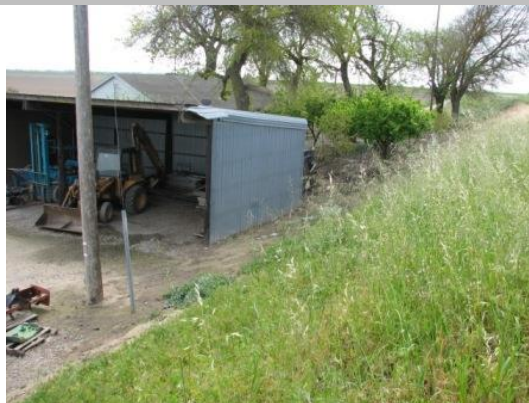
Photo 1 of 1 : SP_2015_RD1500_189_42_20150401_00036.jpg

LM Start	23.77	Rating **	M	Issue No.	42
LM End	23.77	Issue Type +	En	Location *	LS
Category	Earthen Levee			GPS Latitude/Longitude	
				Start	End
Item	Encroachments			38.931838 °	38.931838 °
				-121.834437 °	-121.834437 °
DWR ID	DWR_RD1500_01_s _ 2012_42				
Action/Comments					
Building					
Inspector Comments: Some equipment at landside toe.

Pole barn and some equipment, photo taken in spring 2010.

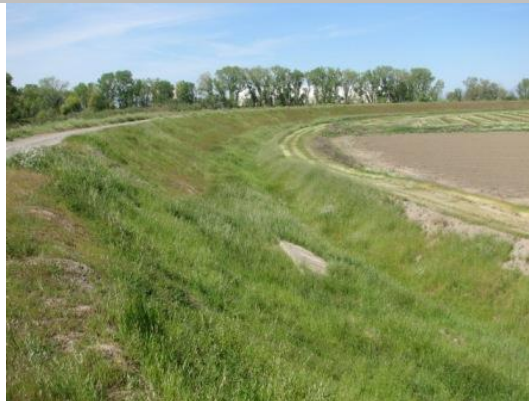
Photo 1 of 2 : SP_2015_RD1500_189_979_20150401_00075.jpg

LM Start	24.16	Rating **	M	Issue No.	979
LM End	24.31	Issue Type +	En	Location *	LS
Category	Earthen Levee			GPS Latitude/Longitude	
				Start	End
Item	Encroachments			38.936282 °	38.938430 °
				-121.830192 °	-121.829359 °
DWR ID	DWR_RD1500_01_s _ 2012_979				
Action/Comments					
Ditch

Agricultural ditch, photo taken in spring 2010.

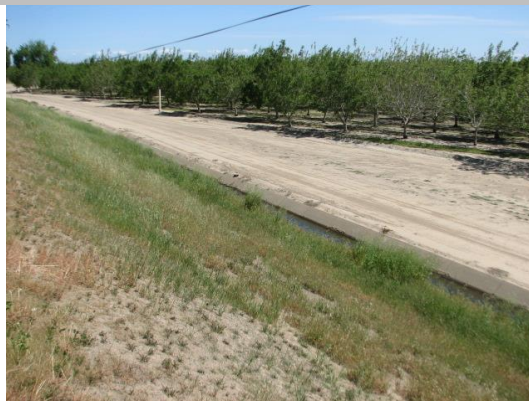
Photo 2 of 2 : SP_2015_RD1500_189_979_20150401_00076.jpg

Agricultural ditch runs along the toe of the levee. Spring 2014

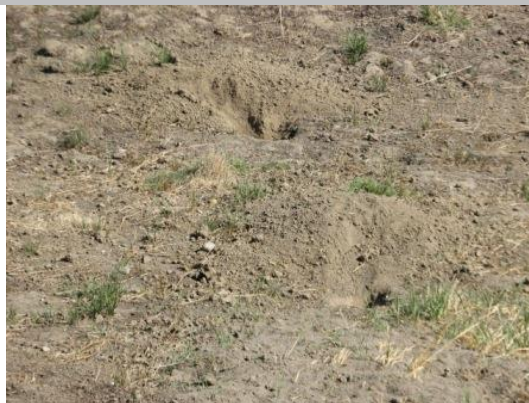
Photo 1 of 2 : SP_2015_RD1500_189_69_20150401_00048.jpg

LM Start	24.88	Rating **	M	Issue No.	69
LM End	24.88	Issue Type +	Ma	Location *	LS
Category	Earthen Levee			GPS Latitude/Longitude	
				Start	End
Item	Animal Control			38.944340 °	38.944340 °
				-121.835790 °	-121.835790 °
DWR ID	DWR_RD1500_01_f_2013_69				
Action/Comments					
Exterminate rodents and backfill and compact or grout burrows.

Multiple rodent burrows on landside slope. Fall 2013

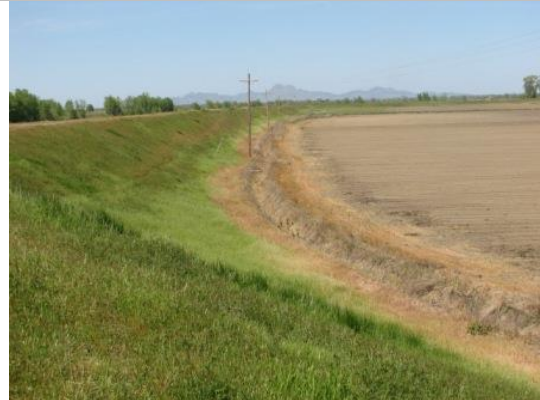
Photo 1 of 2 : SP_2015_RD1500_189_983_20150401_00077.jpg

LM Start	27.29	Rating **	M	Issue No.	983
LM End	27.44	Issue Type +	En	Location *	LS
Category	Earthen Levee			GPS Latitude/Longitude	
				Start	End
Item	Encroachments			38.972440 °	38.972848 °
				-121.825892 °	-121.823098 °
DWR ID	DWR_RD1500_01_s _ 2015_983				
Action/Comments					
Ditch

Agricultural ditch, photo taken in spring 2010.

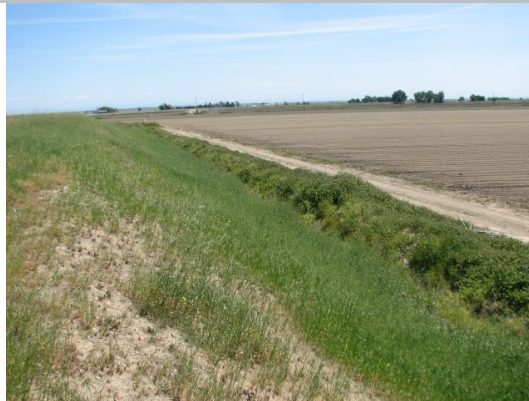
Photo 2 of 2 : SP_2015_RD1500_189_983_20150401_00078.jpg

LM Start	27.29	Rating **	M	Issue No.	983 (cont)
LM End	27.44	Issue Type +	En	Location *	LS
Category	Earthen Levee			GPS Latitude/Longitude	
				Start	End
Item	Encroachments			38.972440 °	38.972848 °
				-121.825892 °	-121.823098 °
DWR ID	DWR_RD1500_01_s_2015_983				
Action/Comments					
Ditch

The agricultural ditch runs along the toe of the levee. Spring 2014

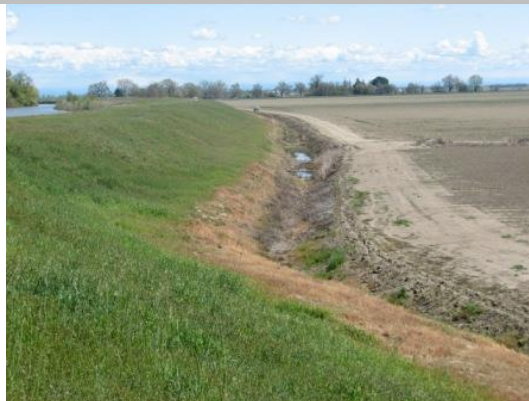
Photo 1 of 2 : SP_2015_RD1500_189_38_20150401_00034.jpg

LM Start	28.22	Rating **	M	Issue No.	38
LM End	29.23	Issue Type +	En	Location *	LS
Category	Earthen Levee			GPS Latitude/Longitude	
				Start	End
Item	Encroachments			38.983081 °	38.988512 °
				-121.819924 °	-121.806463 °
DWR ID	DWR_RD1500_01_s_2012_38				
Action/Comments					
Ditch

The agricultural ditch runs along the toe of the levee, photo taken spring 2012.

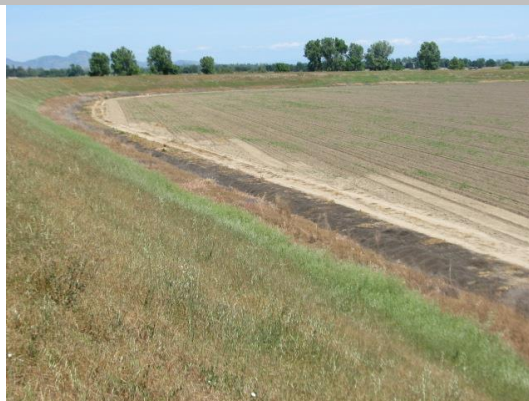
Photo 2 of 2 : SP_2015_RD1500_189_38_20150401_00035.jpg

A current view of the agricultural ditch along the toe. Spring 2014

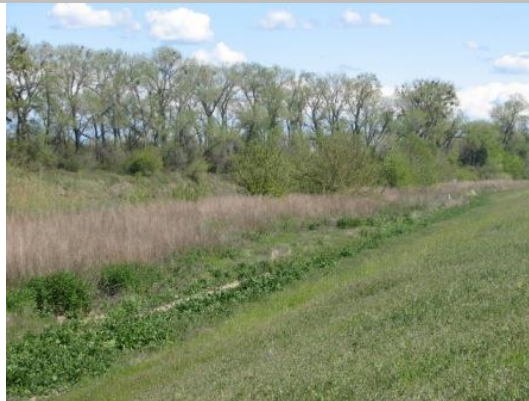
Photo 1 of 2 : SP_2015_RD1500_189_84_20150401_00060.jpg

LM Start	28.95	Rating **	A/W	Issue No.	84
LM End	29.17	Issue Type +	Ma	Location *	WS
Category	Earthen Levee			GPS Latitude/Longitude	
				Start	End
Item	Vegetation			38.988078 °	38.988595 °
				-121.811692 °	-121.807532 °
DWR ID	DWR_RD1500_01_s _ 2012_84				
Action/Comments					
Environmental Requirements.

A photo of the revegetation site.

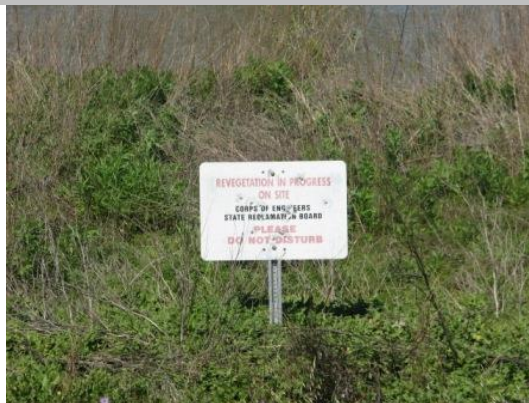
Photo 2 of 2 : SP_2015_RD1500_189_84_20150401_00061.jpg

Another revegetation site on the waterside berm, photo taken spring 2012.

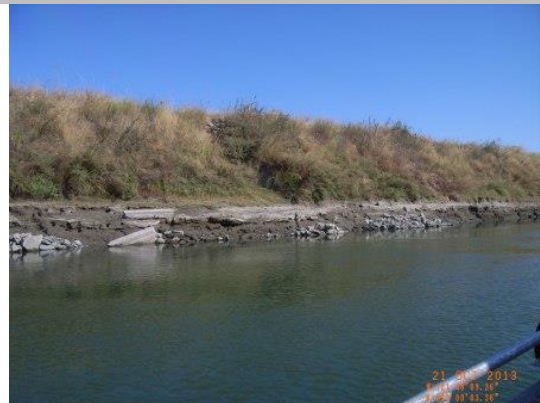
Photo 1 of 1 : SP_2015_RD1500_189_29_20150401_00026.jpg

LM Start	30.60	Rating **	M	Issue No.	29
LM End	30.91	Issue Type +	Ma	Location *	WS
Category	Supplemental			GPS Latitude/Longitude	
				Start	End
Item	USACE Erosion Survey			38.999745 °	39.001413 °
				-121.800898 °	-121.802889 °
DWR ID	DWR_RD1500_01_f_2014_29				
Action/Comments					
Inspector Comments: 2000 - Eroding, vertical berm slope over a vertical cohesive toe; slow erosion but getting close to the toe. 2002 - Erosion is getting close to the levee, still eroding with some new small slumps. 2004 - Some minor new erosion. 2006 - Some new erosion, cleaned off older scars and slump faces. 2008 - New, small, partial rotational failure. 2011 - Some new minor erosion. 2013: No observed changes. [2013 Site ID: SAC_116-0_L]

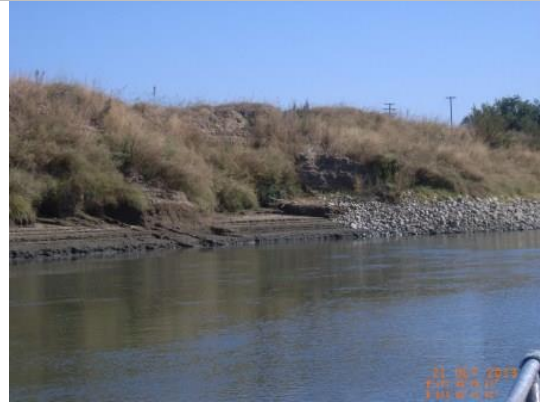
Photo 1 of 1 : SP_2015_RD1500_189_34_20150401_00031.jpg

Action/Comments					
Inspector Comments: 2003 - New sedimentation and some new small toe scallops at the upstream end; downstream end has some new erosion. 2004 - Some new erosion at the toe and upper bank and some small new rotational failures (mainly minor, except at the downstream end). 2007 - Some new slumps. 2009 - Some new scallops and site was extended upstream. 2010 - New deposition along upstream end of site, however there is also new erosion throughout the site. Site seems to be worsening, and eroding fast. Large habitat for bank swallows. 2011 - Some new minor erosion. 2012 - Minor new erosion. 2013: No observed changes. [2013 Site ID: SAC_116-5_L]

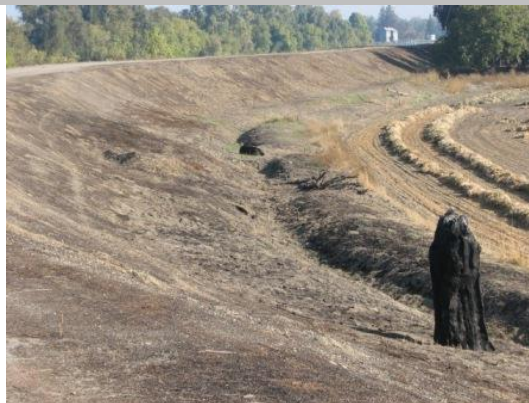
Photo 1 of 1 : SP_2015_RD1500_189_60_20150401_00047.jpg

LM Start	32.42	Rating **	M	Issue No.	60
LM End	32.58	Issue Type +	En	Location *	LS
Category	Earthen Levee			GPS Latitude/Longitude	
				Start	End
Item	Encroachments			39.013720 °	39.015640 °
				-121.825038 °	-121.823397 °
DWR ID	DWR_RD1500_01_s_2012_60				
Action/Comments					
Ditch

Older, unused agricultural ditch. Tree stump needs to be removed.

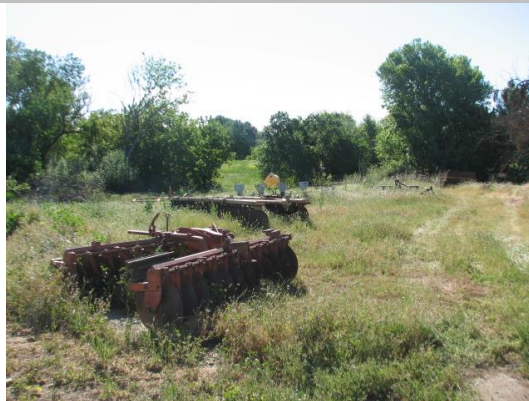
Photo 2 of 2 : SP_2015_RD1500_190_12_20150401_00006.jpg

LM Start	0.00	Rating **	M	Issue No.	12 (cont)	
LM End	0.00	Issue Type +	Ma	Location *	WS	
Category	Earthen Levee			GPS Latitude/Longitude		
				Start		End
Item	Encroachments			38.761121 °	38.761121 °	
				-121.674592 °	-121.674592 °	
DWR ID	DWR_RD1500_02_s _ 2012_12					
Action/Comments						
Equipment

Farm equipment is on the levee crown. Spring 2014

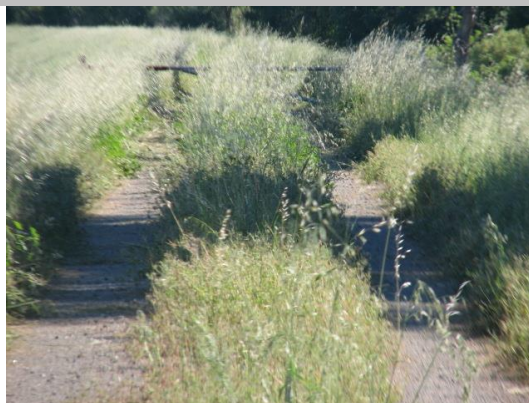
Photo 1 of 1 : SP_2015_RD1500_190_302_20150401_00011.jpg

LM Start	0.16	Rating **	M	Issue No.	302
LM End	1.85	Issue Type +	Ma	Location *	CR
Category	Earthen Levee			GPS Latitude/Longitude	
				Start	End
Item	Vegetation			38.762750 °	38.782985 °
				-121.672501 °	-121.655599 °
DWR ID	DWR_RD1500_02_s _ 2014_302				
Action/Comments					
Keep the crown roadway free of vegetation.

Control unwanted vegetation on the levee crown Spring 2014

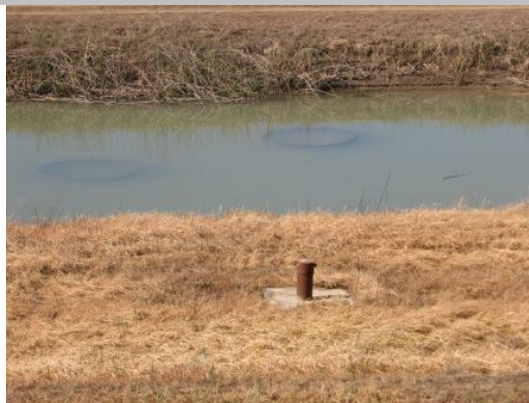
Photo 1 of 1 : SP_2015_RD1500_190_4_20150401_00001.jpg

LM Start	14.13	Rating **	A/W	Issue No.	4
LM End	14.13	Issue Type +	Ma	Location *	LS
Category	Earthen Levee			GPS Latitude/Longitude	
				Start	End
Item	Underseepage Relief Wells			38.947582 °	38.947582 °
				-121.669740 °	-121.669740 °
DWR ID	DWR_RD1500_02_s_2012_4				
Action/Comments

The relief well at boil 12, photo taken spring 2012.

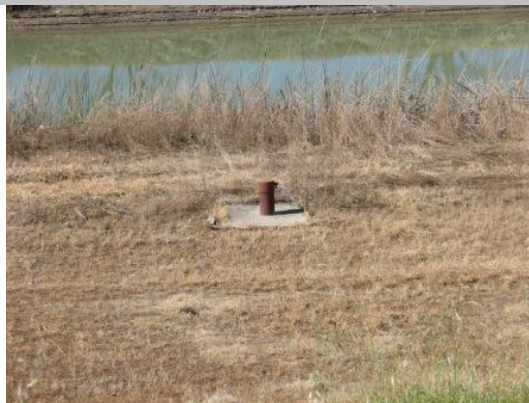
Photo 1 of 1 : SP_2015_RD1500_190_11_20150401_00004.jpg

LM Start	14.47	Rating **	A/W	Issue No.	11
LM End	14.47	Issue Type +	Ma	Location *	LS
Category	Earthen Levee			GPS Latitude/Longitude	
				Start	End
Item	Underseepage Relief Wells			38.951398 °	38.951398 °
				-121.673827 °	-121.673827 °
DWR ID	DWR_RD1500_02_s_2012_11				
Action/Comments

A relief well at boil 16, photo taken spring 2012.

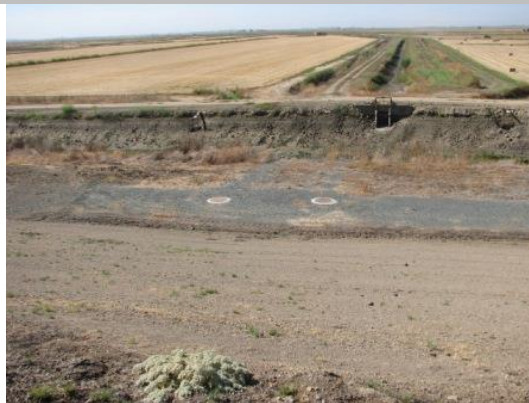
Photo 1 of 2 : SP_2015_RD1500_190_13_20150401_00007.jpg

LM Start	18.18	Rating **	A/W	Issue No.	13
LM End	18.18	Issue Type +	Ma	Location *	LS
Category	Earthen Levee			GPS Latitude/Longitude	
				Start	End
Item	Underseepage Relief Wells			38.987092 °	38.987092 °
				-121.725097 °	-121.725097 °
DWR ID	DWR_RD1500_02_s_2012_13				
Action/Comments

Two of five drains on the landside berm. Photo fall 2012.

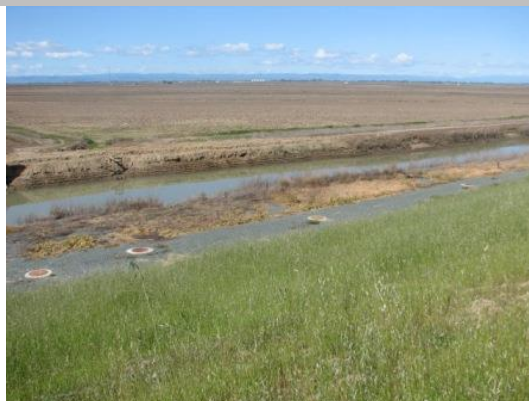
Photo 2 of 2 : SP_2015_RD1500_190_13_20150401_00008.jpg

LM Start	18.18	Rating **	A/W	Issue No.	13 (cont)
LM End	18.18	Issue Type +	Ma	Location *	LS

Toe drainage systems along the toe berm four total, photo taken spring 2012.

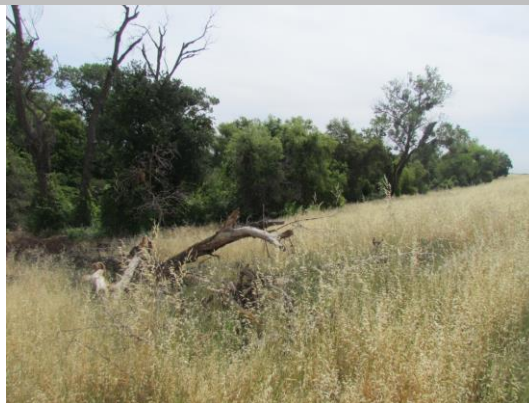
Photo 1 of 1 : SP_2015_RD1500_190_584_20150514_00814.jpg

LM Start	18.19	Rating **	M	Issue No.	584
LM End	18.19	Issue Type +	Ma	Location *	WS
Category	Earthen Levee			GPS Latitude/Longitude	
				Start	End
Item	Encroachments			38.987247 °	38.987247 °
				-121.725271 °	-121.725271 °
DWR ID	DWR_RD1500_02_s_2015_584				
Action/Comments					
Tree or limb Inspector Comments: A tree broke and fell onto the waterward side of the levee.

View of the fallen tree on the waterward side of the levee looking downstream. Spring 2015.

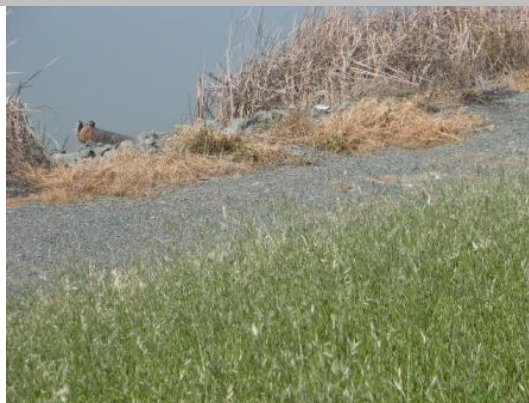
Photo 1 of 2 : SP_2015_RD1500_190_15_20150401_00009.jpg

LM Start	18.41	Rating **	A/W	Issue No.	15
LM End	18.41	Issue Type +	Ma	Location *	LS
Category	Earthen Levee			GPS Latitude/Longitude	
				Start	End
Item	Underseepage Relief Wells			38.989813 °	38.989813 °
				-121.727763 °	-121.727763 °
DWR ID	DWR_RD1500_02_s_2015_15				
Action/Comments

Another toe drainage system close by, photo taken spring 2012.

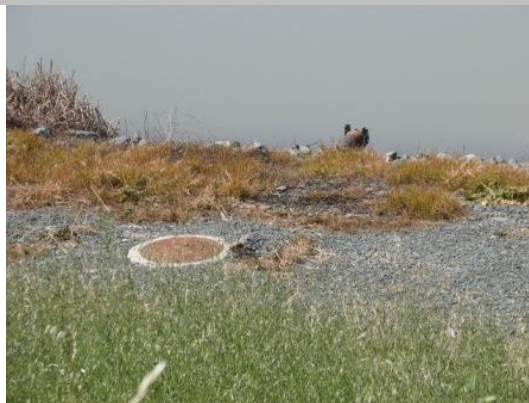
Photo 2 of 2 : SP_2015_RD1500_190_15_20150401_00010.jpg

LM Start	18.41	Rating **	A/W	Issue No.	15 (cont)
LM End	18.41	Issue Type +	Ma	Location *	LS

A toe drainage system at the toe berm, photo taken spring 2012.
